Space Shuttle Lessons Learned Knowledge Sharing Forum

NASA KSC Lesson Learn Entry: 3236 Solid Rocket Booster (SRB) Flame Trench Refractory Failure Modes

**Gabor Tanacs
Armand Gosselin
USA L&RS Engineering
January 27, 2011**

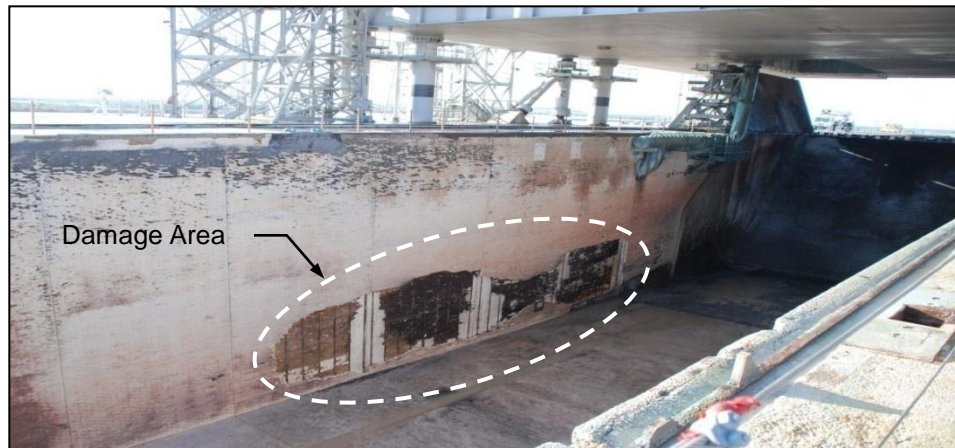
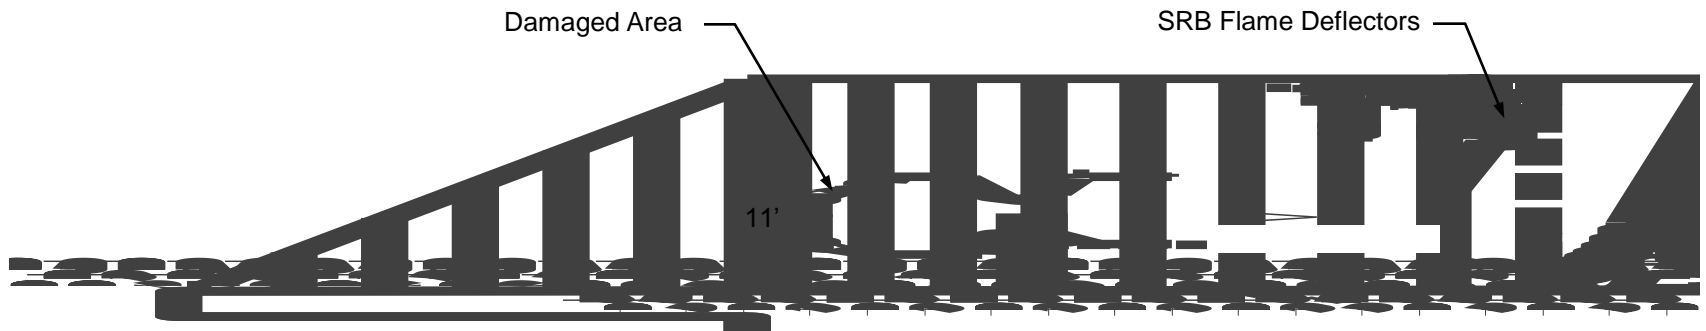
Flame Trench East Wall Damaged Area

- East Brick Wall Damage
 - Estimated Total Bricks On East Wall ~ 22,000
 - Estimated Lost Bricks ~ 3,540 (16% Loss of East Wall)

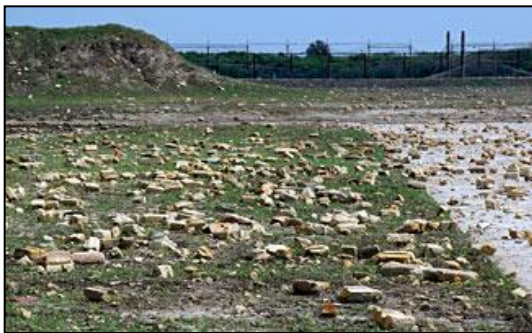
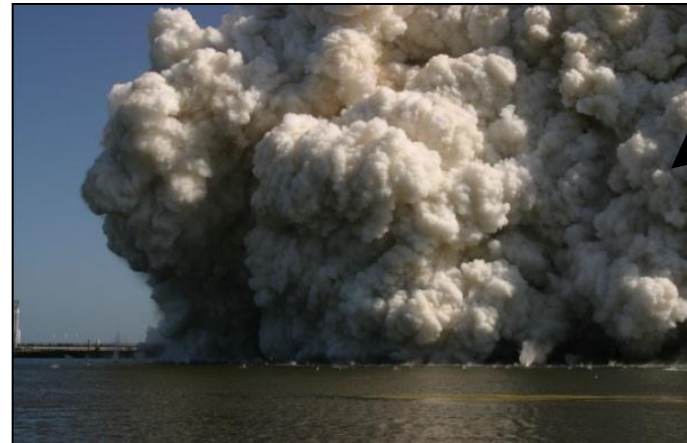
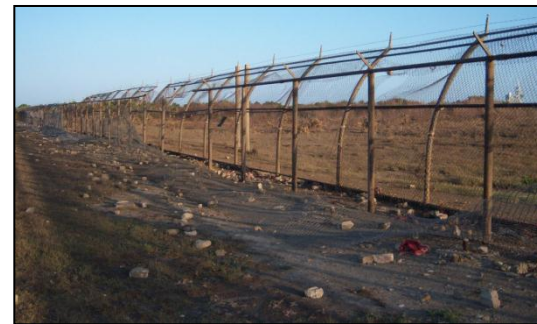
Brick Impact Mapping

- Perimeter Fence Damage
 - Fence at ~1800 ft from damage initiation
- Bricks Beyond Perimeter Fence

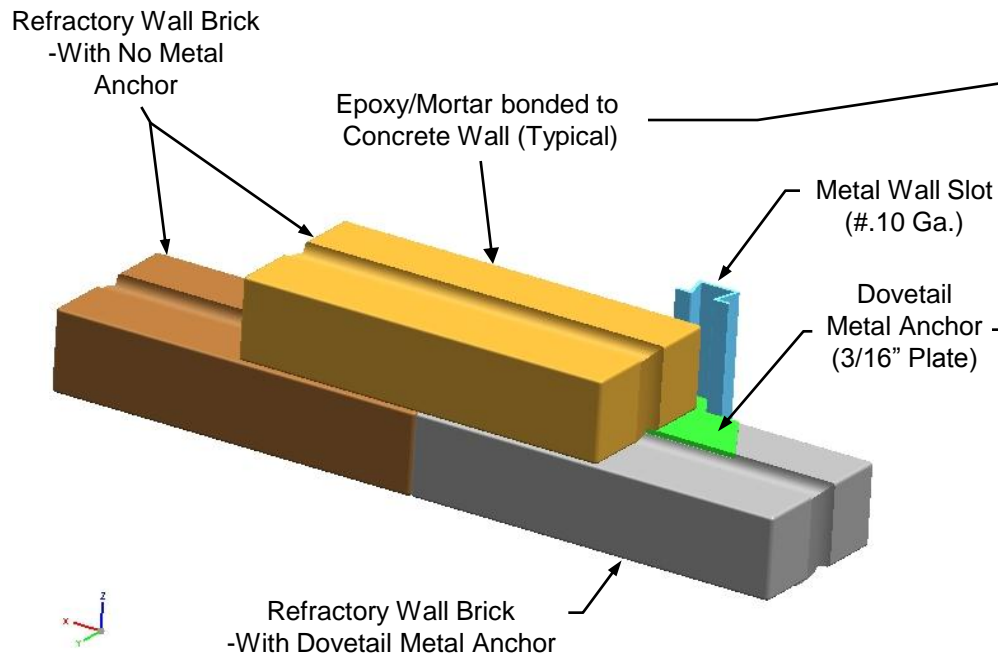
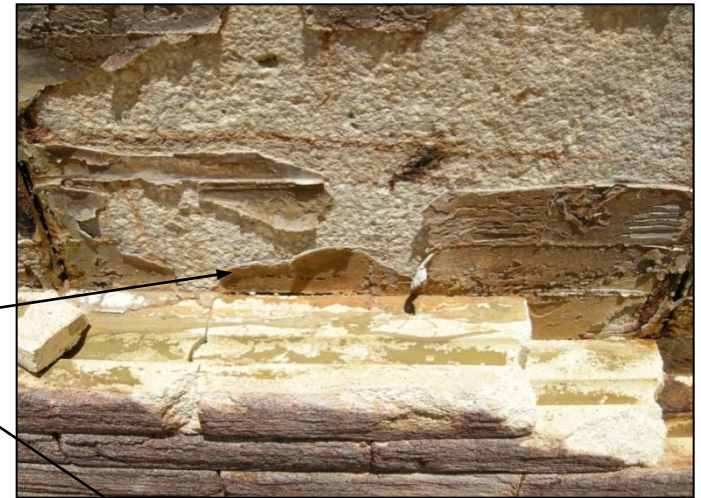
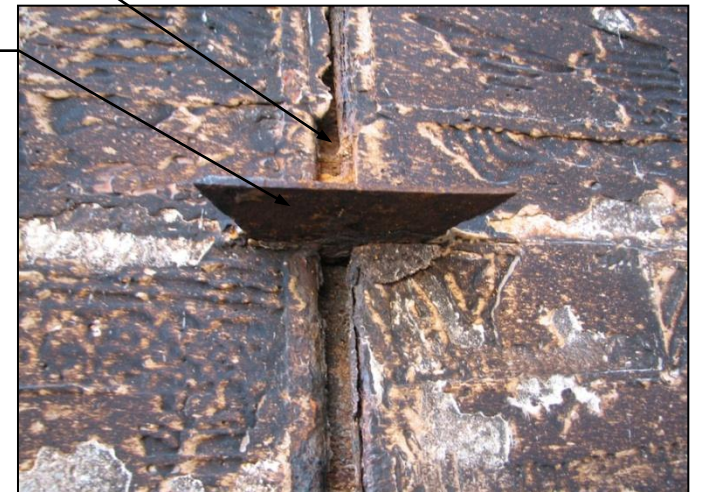
Description of Driving Event (continued)

- **Brick-to-Wall Bond Failure**
 - **Dovetail Anchor Plate Corrosion**
 - **Epoxy Degradation**
